# Manhole Inspection Summary

Manhole # S11EE2030MH

Insp Date: **10/10/06 10:50 AM**

**Location** Address: **2217 CROSS COUNTY BLVD**

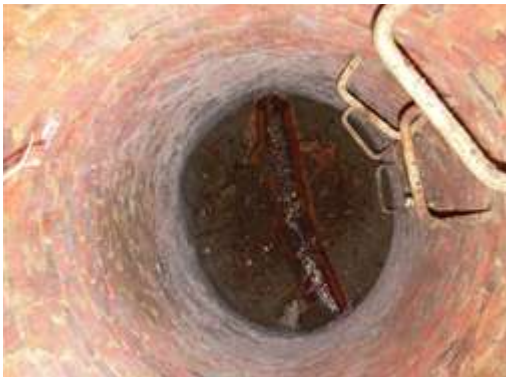
Top View

Evidence of surcharge - Bench debris.  
Channel debris.

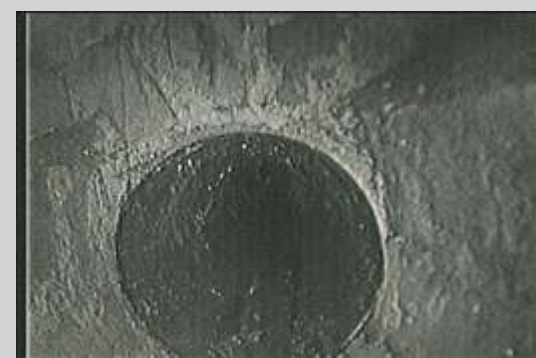
### 8 in. Circular Gravity Sewer Pipe Out @ 12 O'Clock

Barrel root intrusion. Root intrusion inside of pipe.

Infiltration: **Evidence** Pipe Seal Cond: **Cracked**

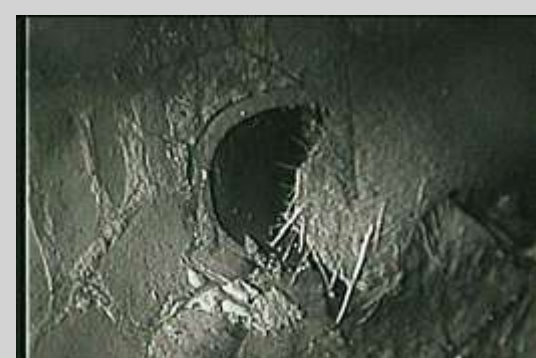
### 8 in. Circular Gravity Sewer Pipe In @ 5 O'Clock

Barrel root intrusion.

Infiltration: **Evidence** Pipe Seal Cond: **Roots**

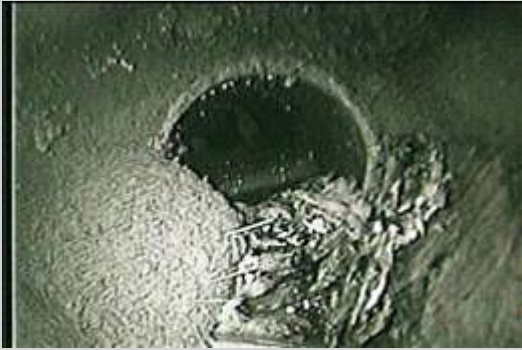
Pipe In @ 7 O'Clock

Channel root intrusion.

Deposits: ☐ None ☐ **Mud** ☐ Sludge ☒ **Debris** ☐ Grease

Silt Depth: **3** (in.) Deposits Extent: **Medium**

Pipe Seal Cond: **Roots**

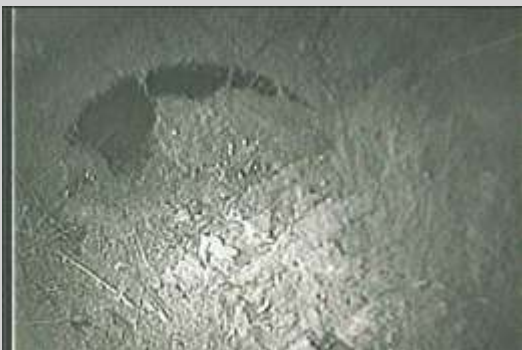
Pipe In @ 9 O'Clock

Channel root intrusion.

Deposits: ☐ None ☒ **Mud** ☐ Sludge ☒ **Debris** ☐ Grease

Silt Depth: **6** (in.) Deposits Extent: **Heavy**

Pipe Seal Cond: **Roots**
